FINAL NON TIME CRITICAL REMOVAL ACTION AFTER ACTION REPORT SOLID WASTE
MANAGEMENT UNIT 4 (SWMU 4) ATLANTIC FLEET WEAPONS TRAINING AREA FORMER
NAVAL AMMUNITION SUPPORT DETACHMENT VIEQUES ISLAND PUERTO RICO

**Solid Waste Management Unit 4
Non-Time-Critical Removal Action
After Action Report**

**Atlantic Fleet Weapons Training Area—Vieques
Former Naval Ammunition Support Detachment
Vieques, Puerto Rico**

November 2016

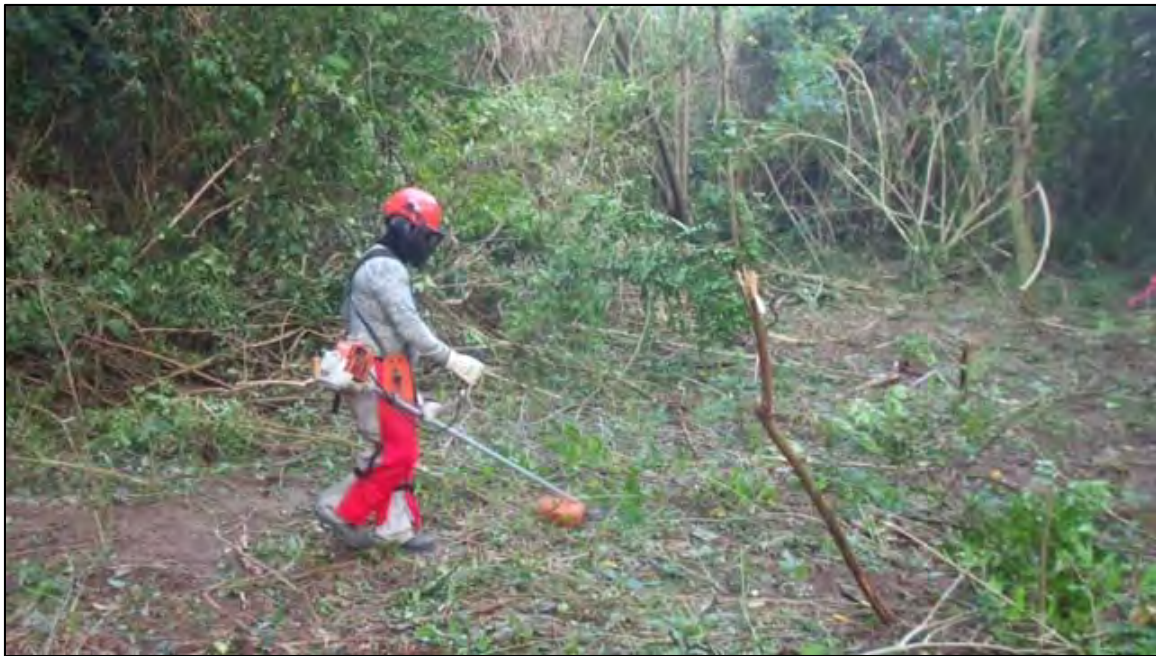
Photo 1 – Vegetation cutting within the “spokes” at SWMU 4

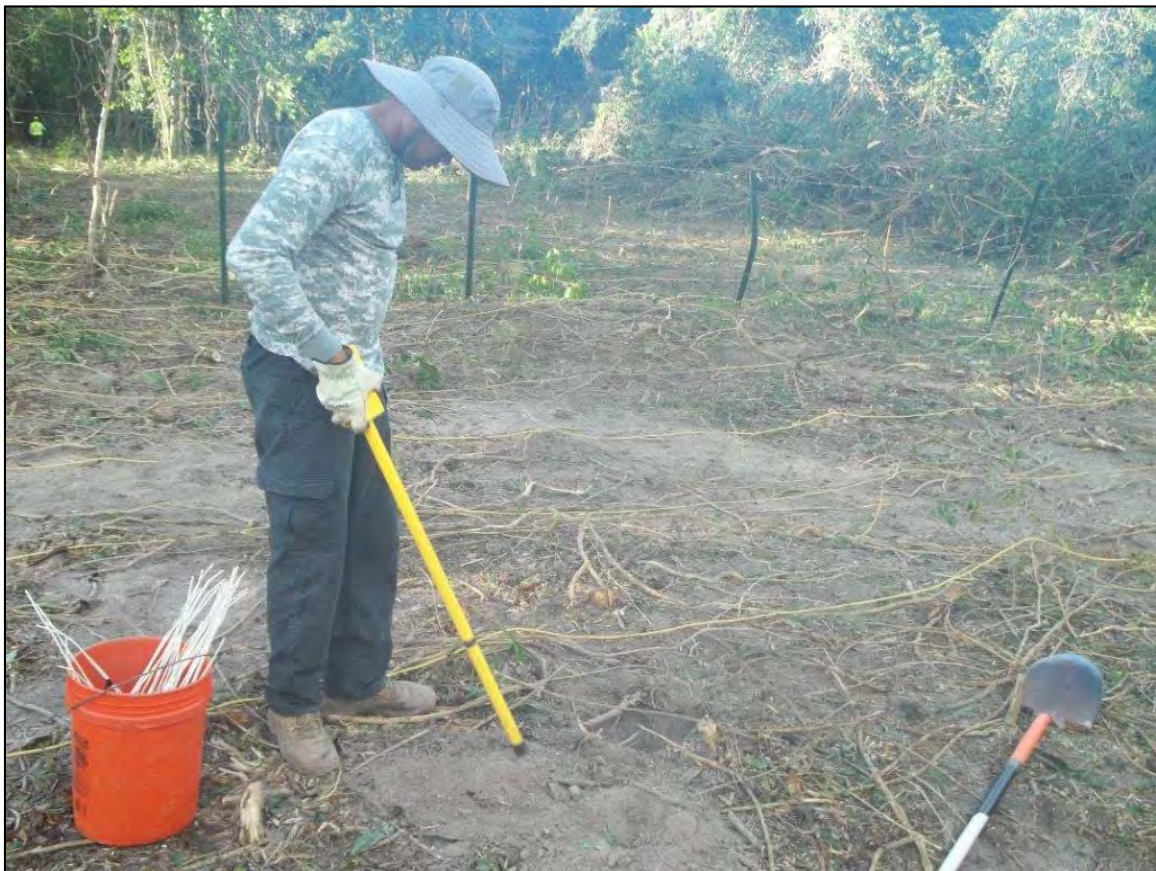
Photo 2 – Mag-and-dig within the “spoke” at SWMU 4

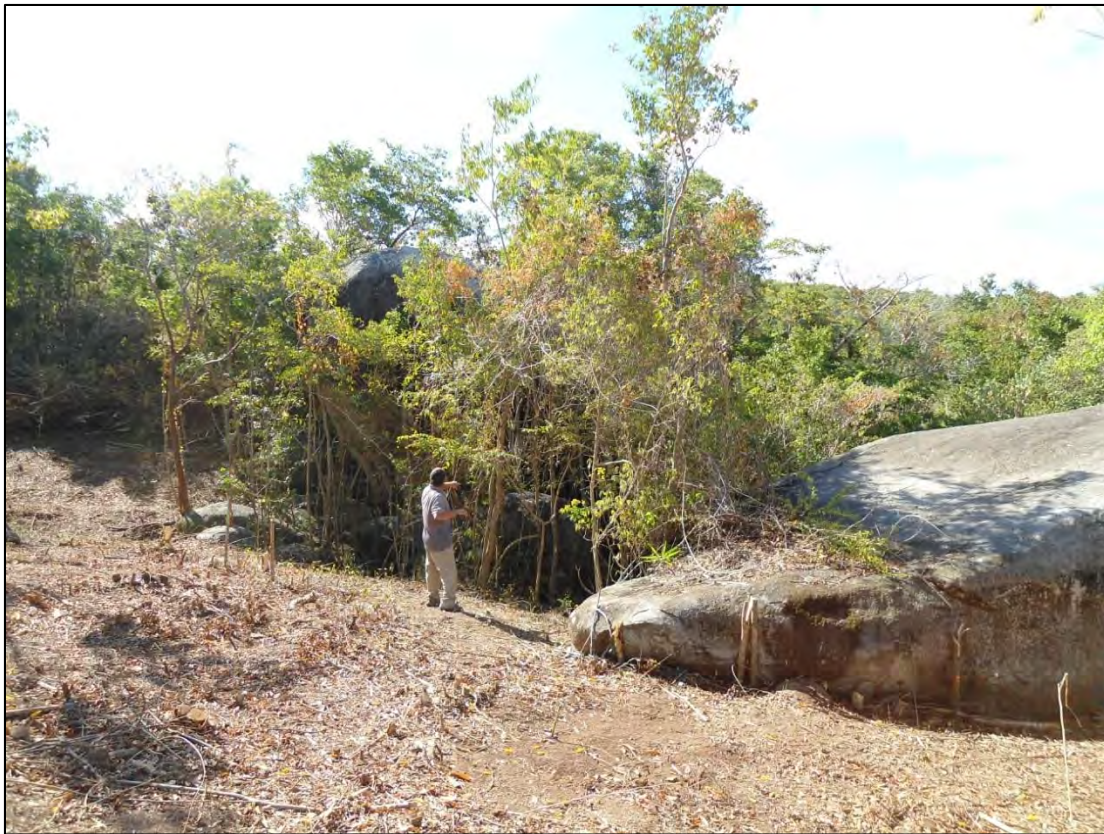
Photo 3 – Large boulders exposed by vegetation cutting along a “spoke” at SWMU 4

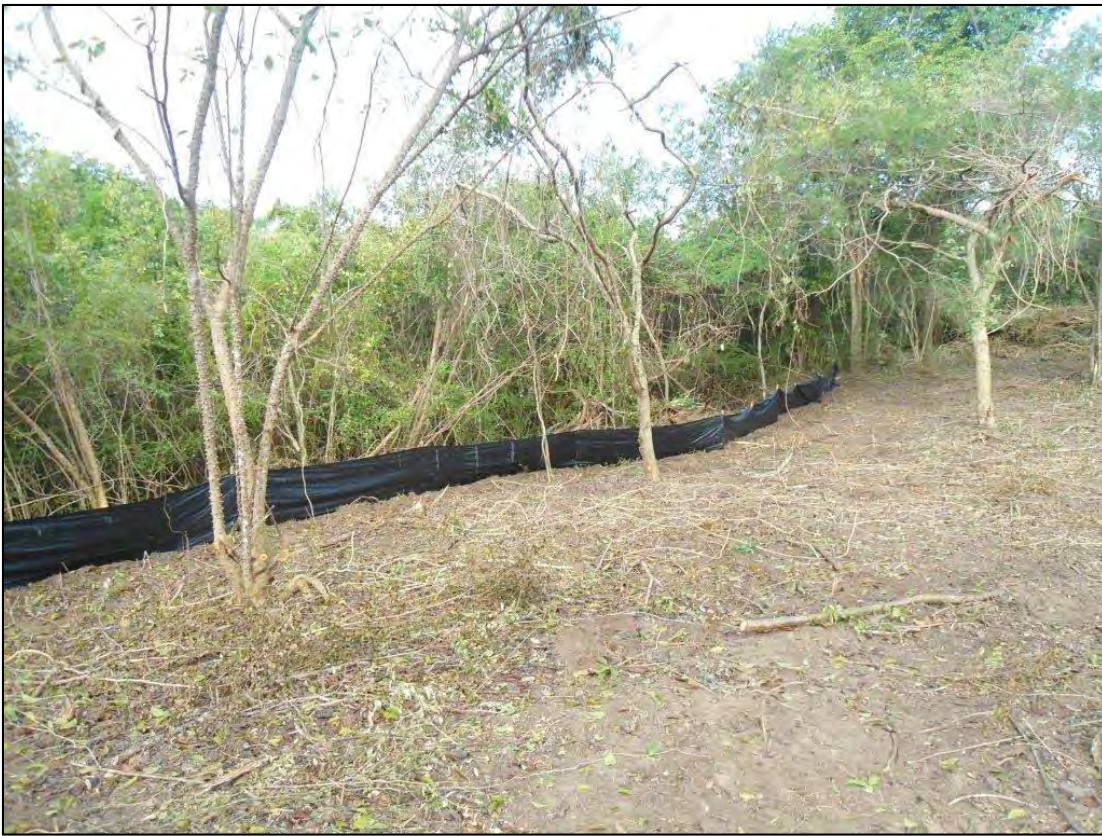
Photo 5 – Erosion control measures along a “spoke” at SWMU 4

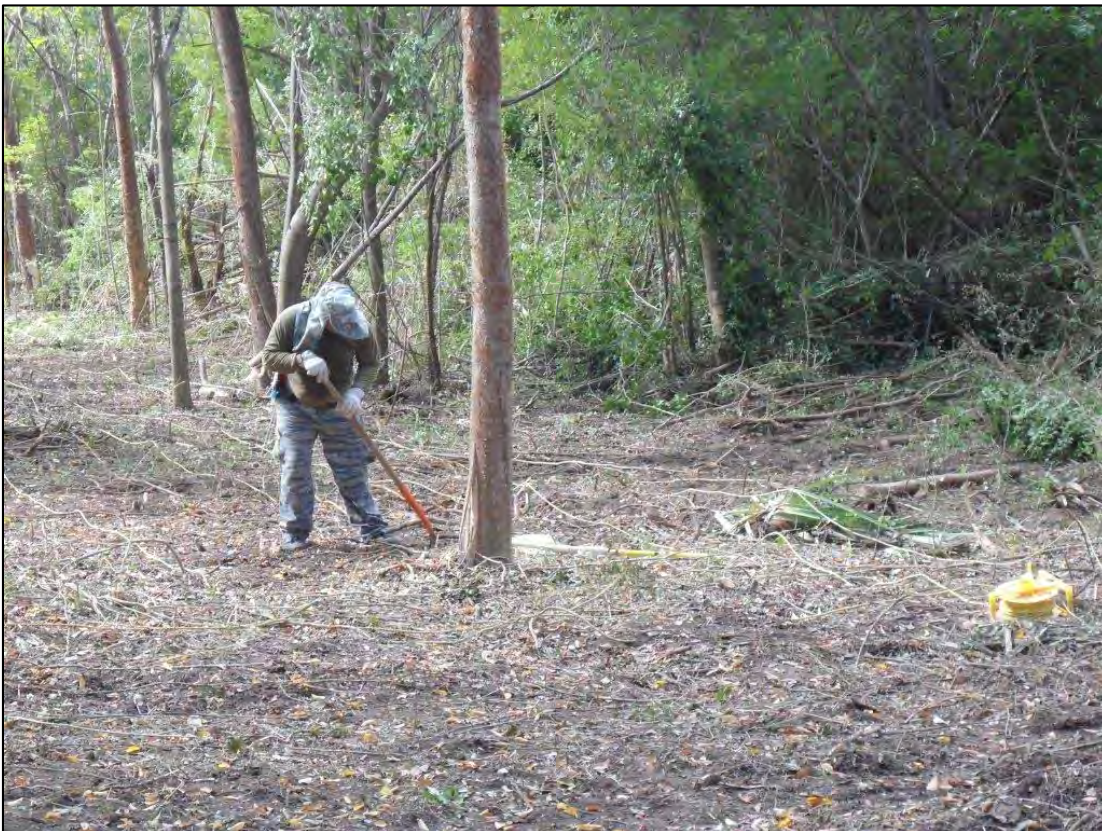
Photo 6 – Mag-and-dig around trees at SWMU 4

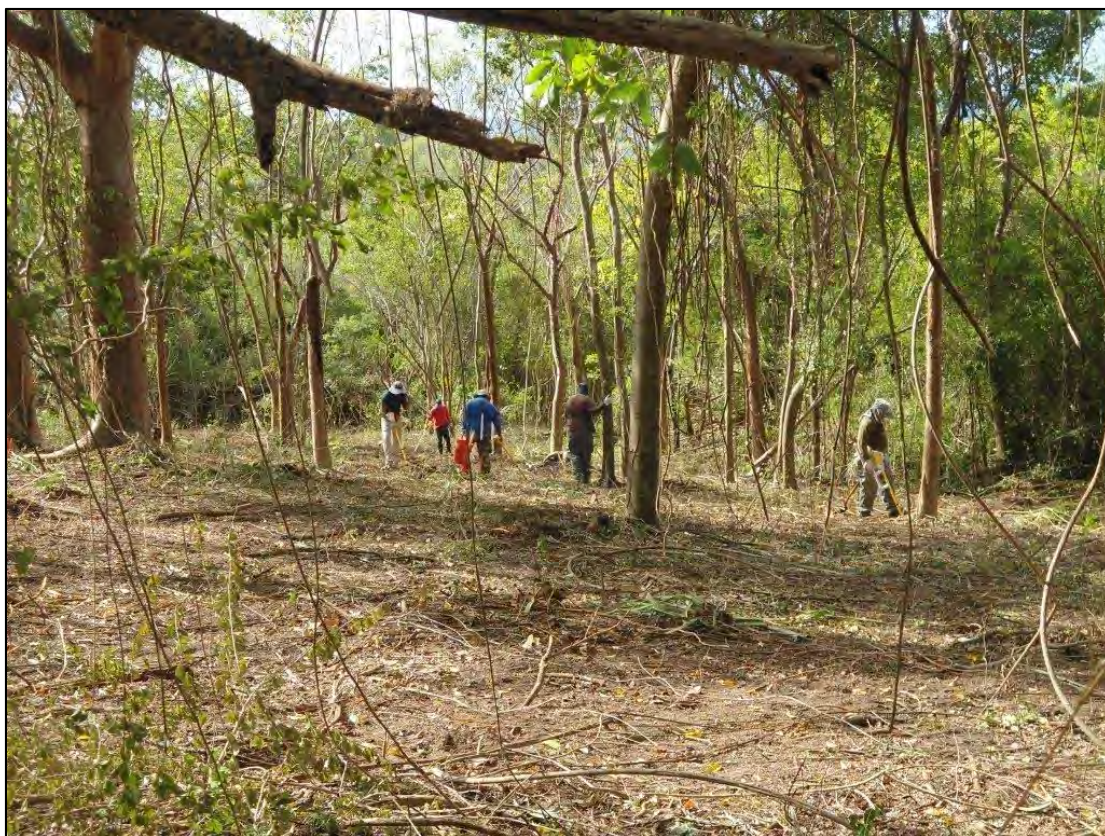
Photo 7 – Mag-and-dig along search lanes at SWMU 4

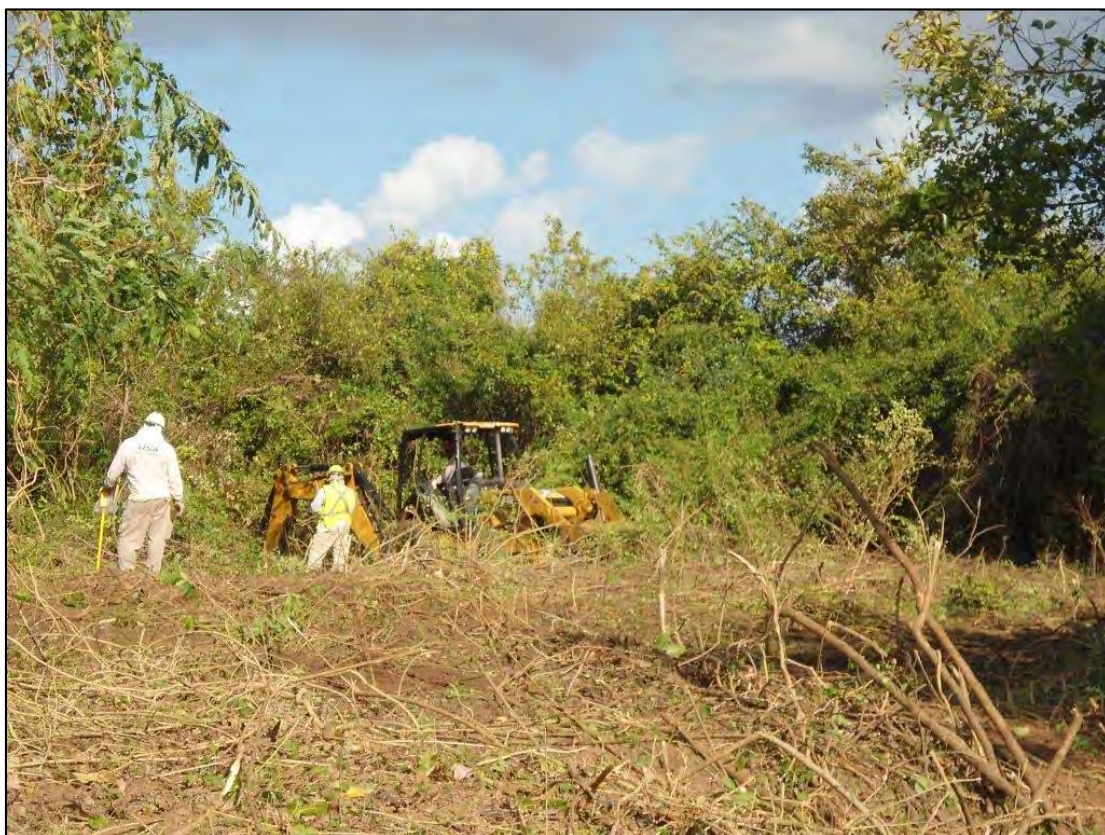
Photo 8 – Vegetation cutting at planned observation tower at SWMU 4

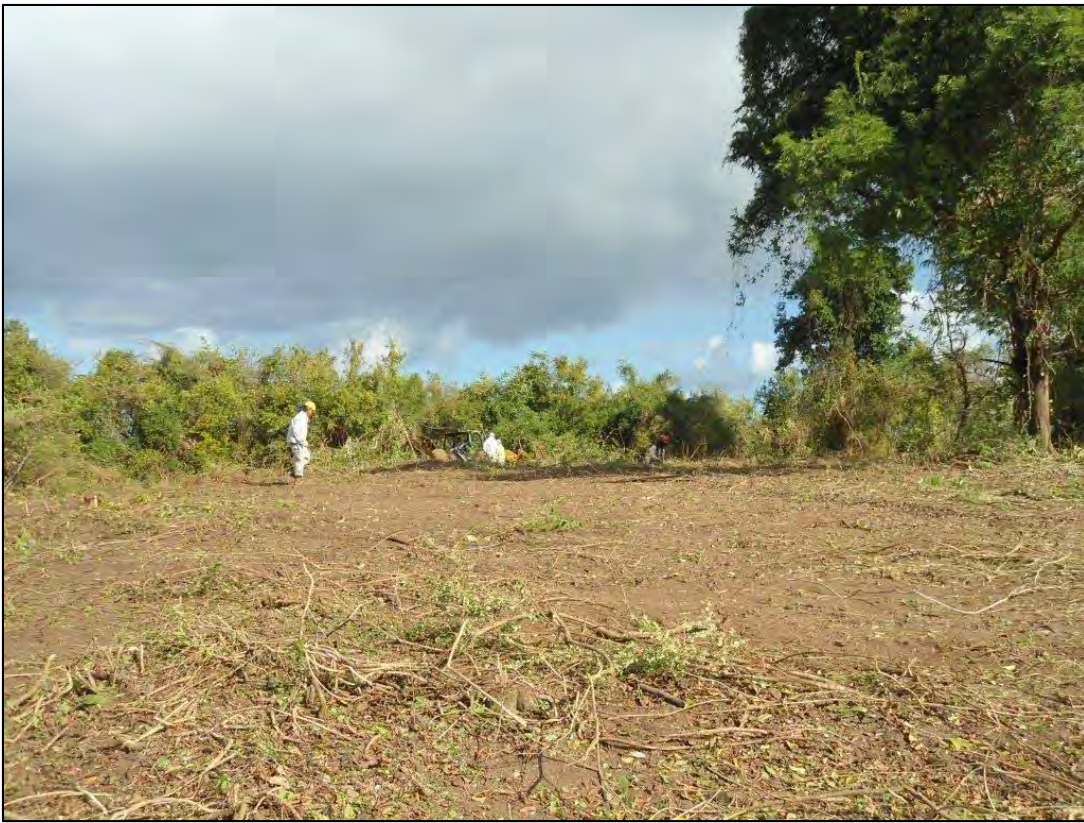
Photo 9 – Vegetation cutting in preparation for DGM survey at SWMU 4

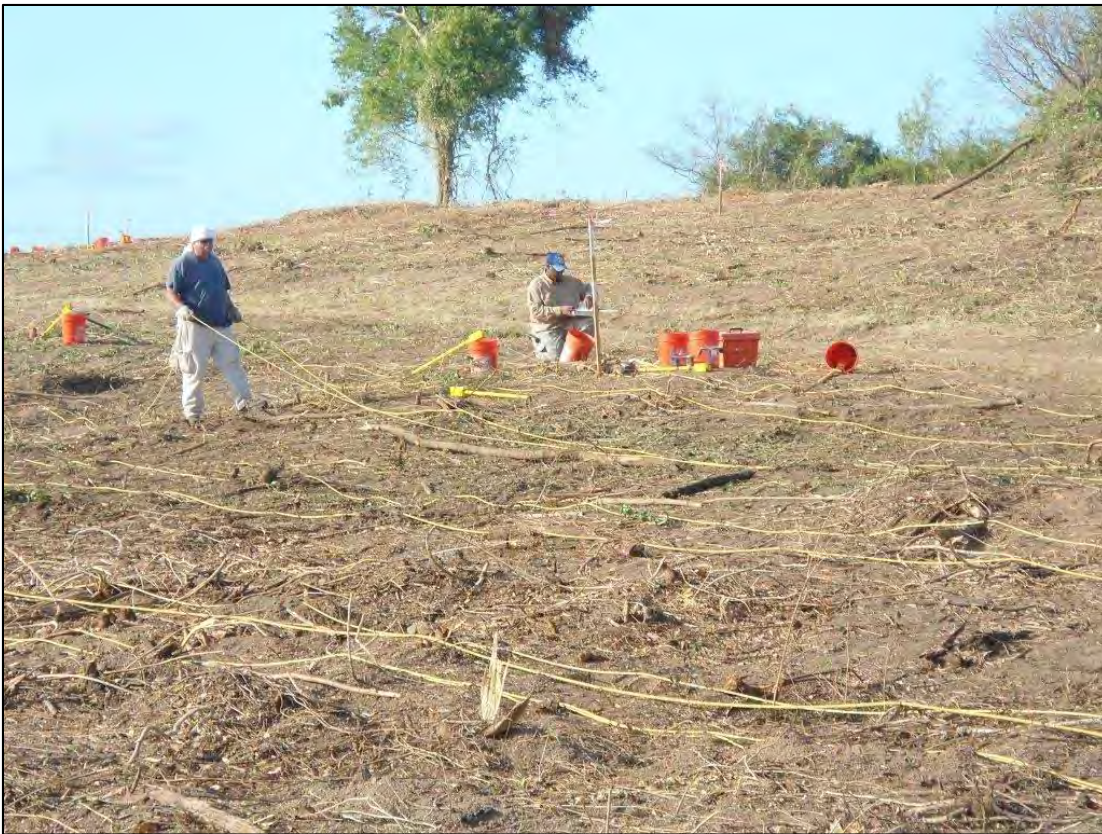
Photo 11 – Surface MEC removal in area to be DGM surveyed at SWMU 4

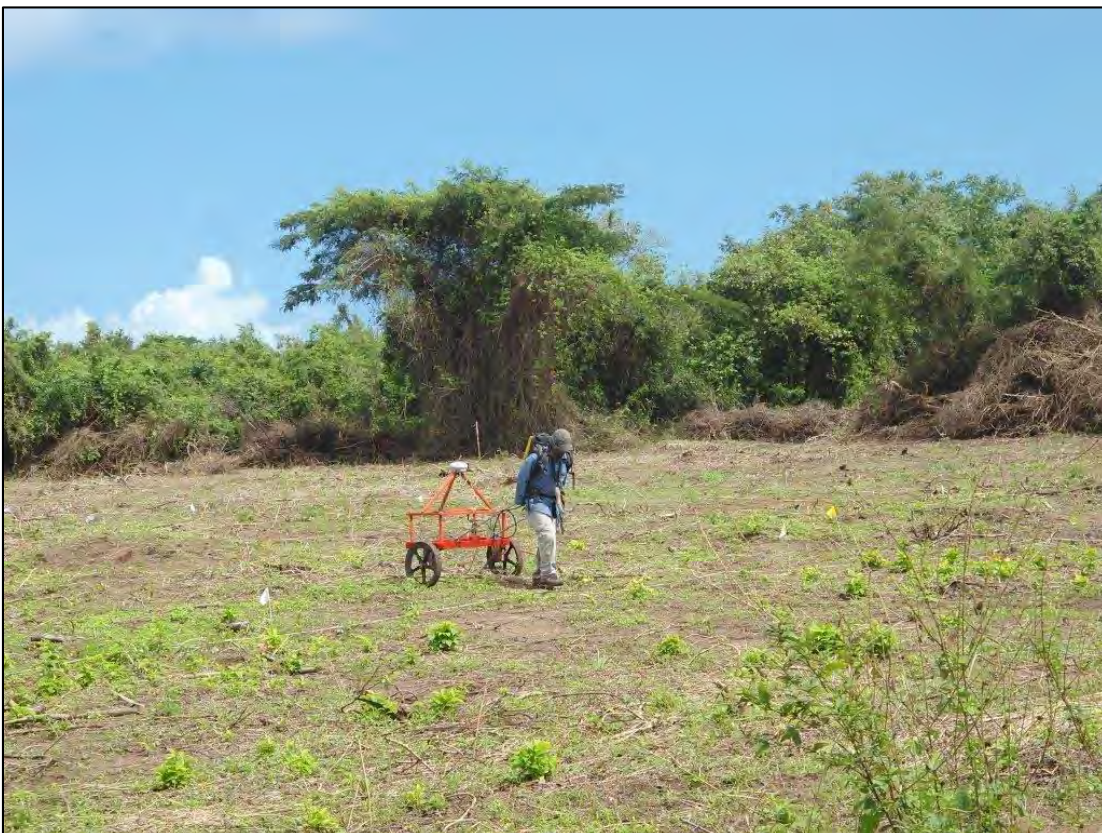
Photo 12 – DGM survey of planned eastern parking area at SWMU 4

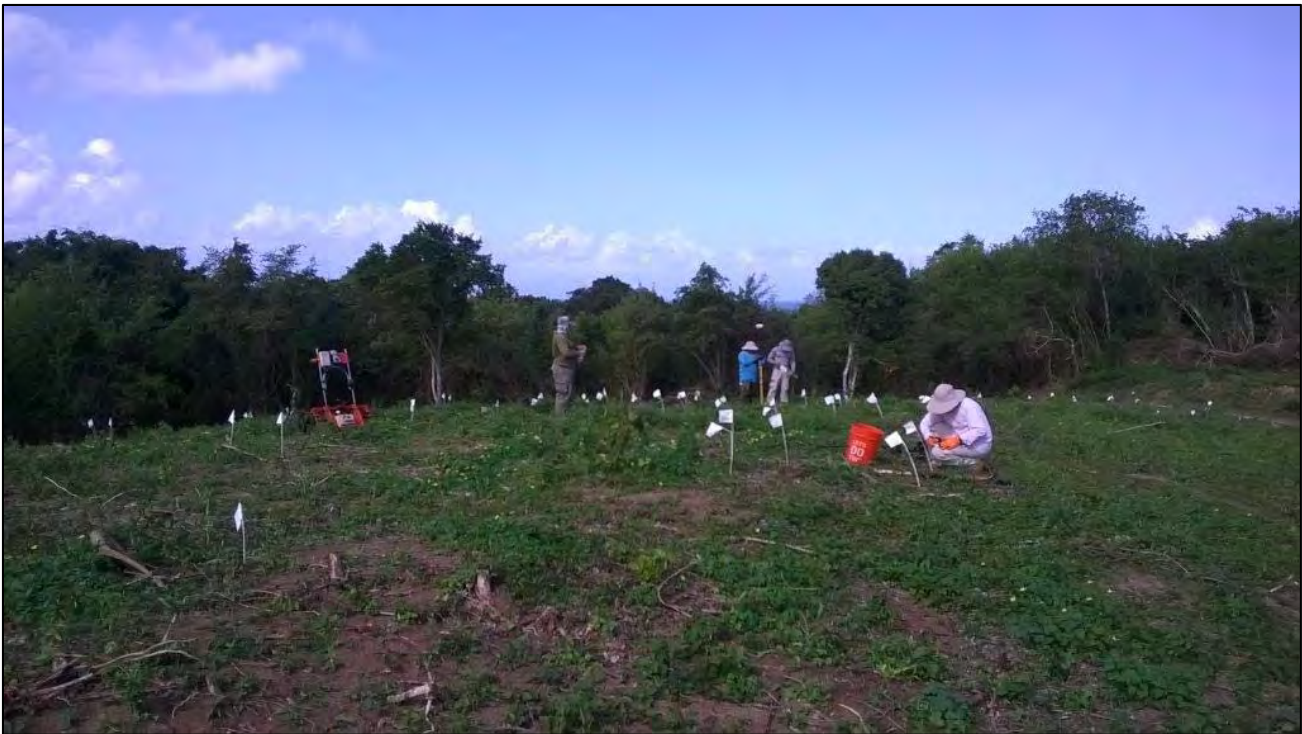
Photo 13 – Excavation of subsurface anomalies at planned eastern parking area at SWMU 4

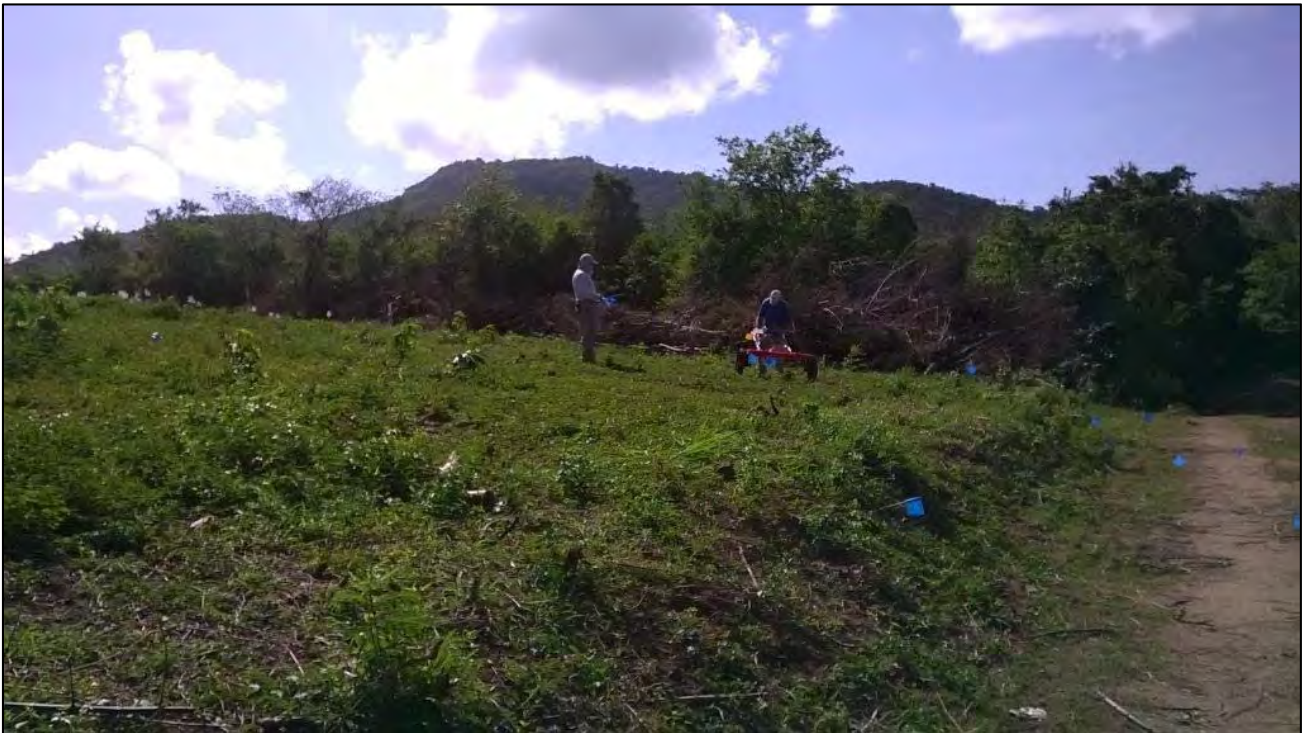
Photo 14 – Quality control of subsurface anomaly excavation at SWMU 4

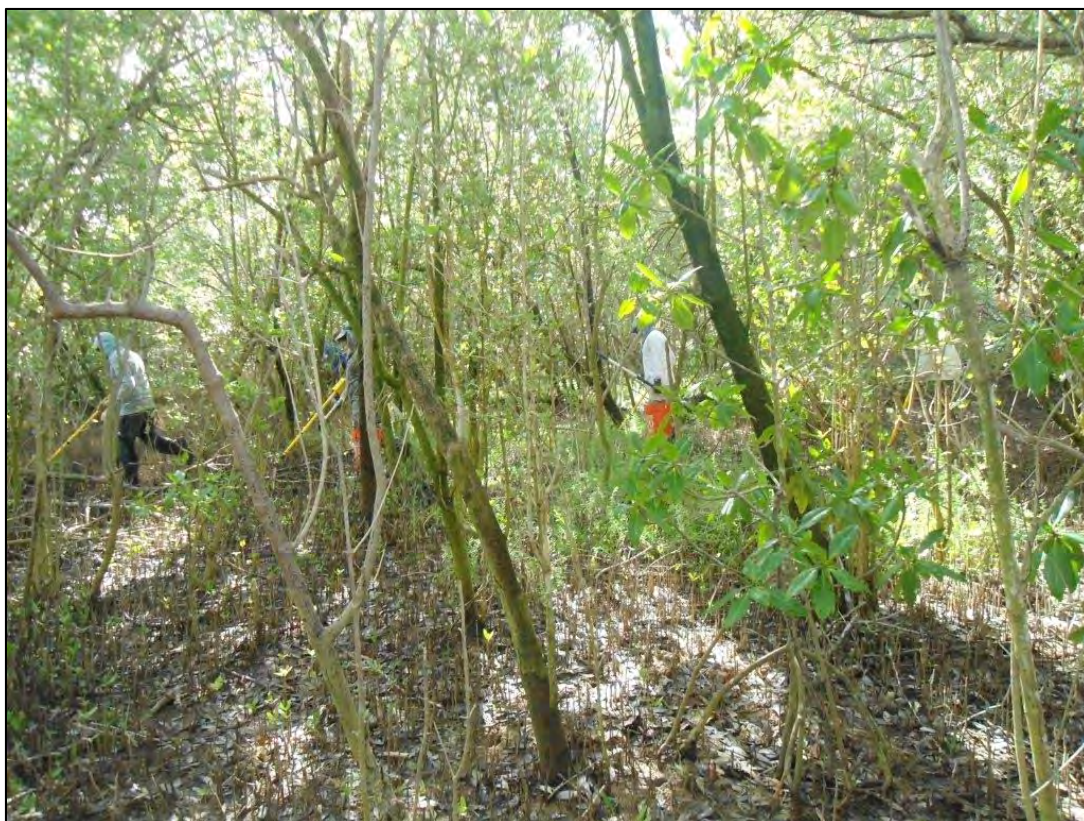
Photo 15 – UXO Technicians conducting mag-and-dig of lagoon fringe at SWMU 4

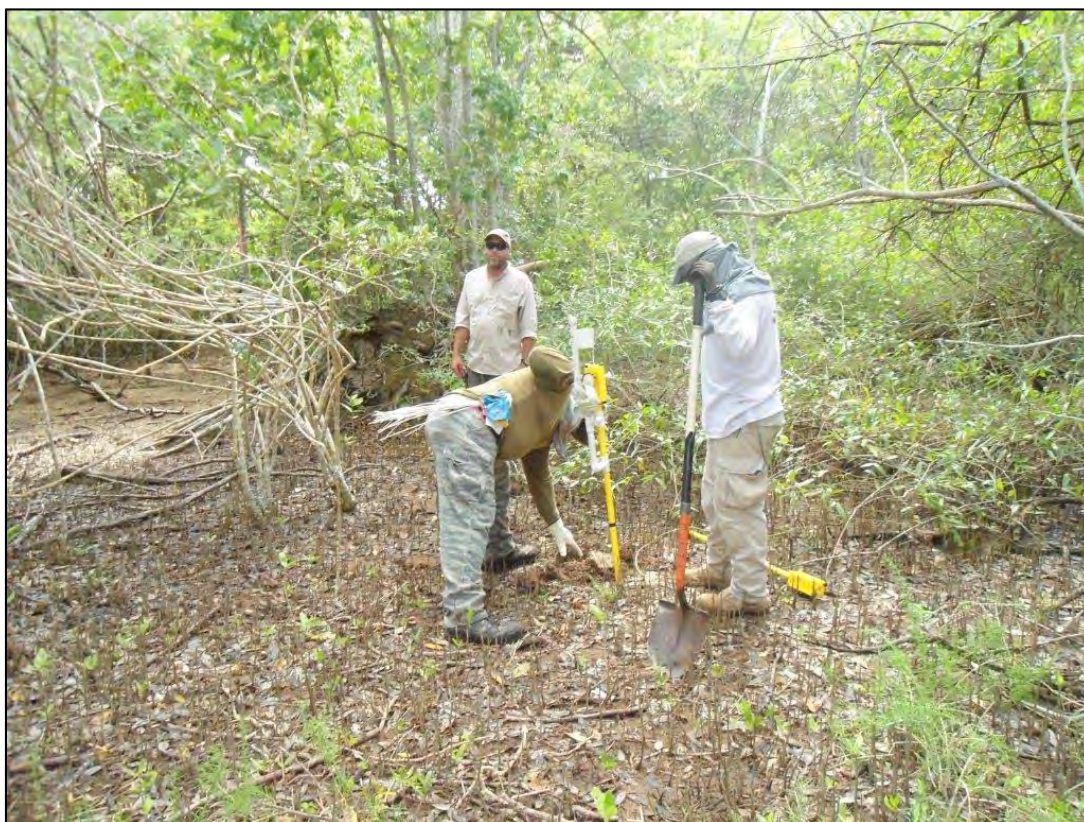
Photo 16 – Excavating subsurface anomaly at the SWMU 4 lagoon fringe

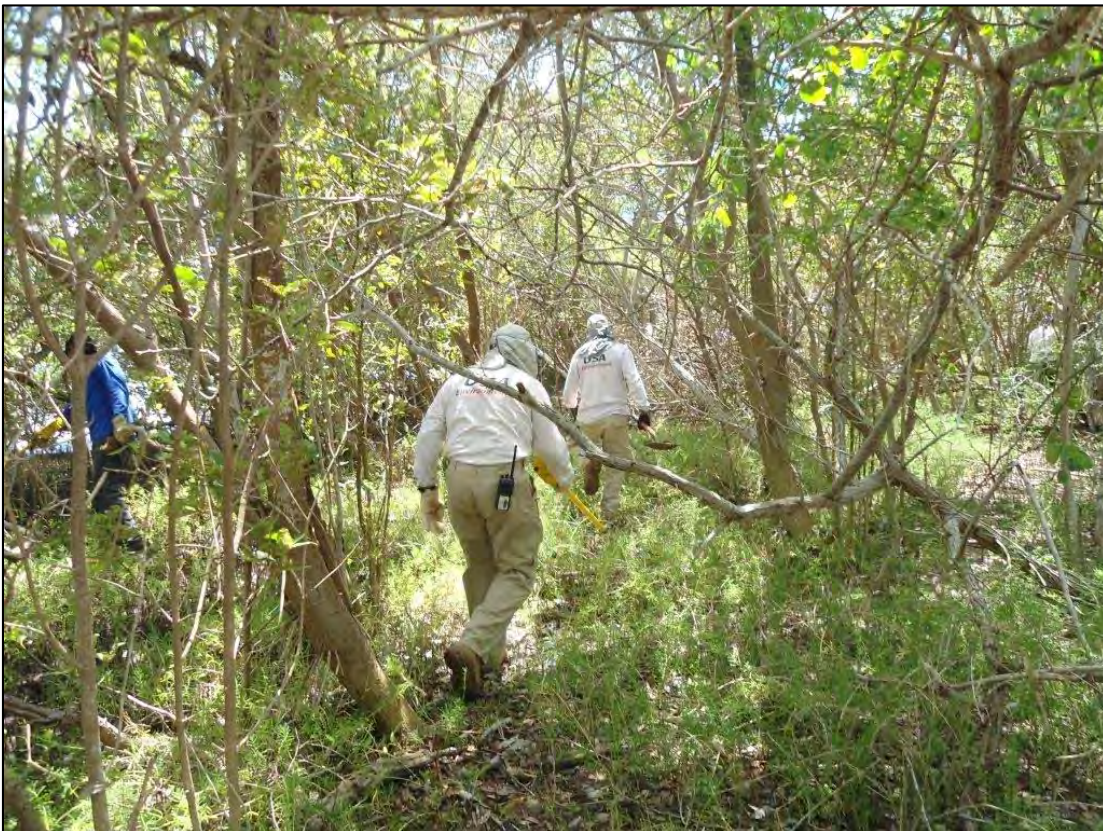
Photo 18 – Quality control following mag-and-dig at the SWMU 4 lagoon fringe

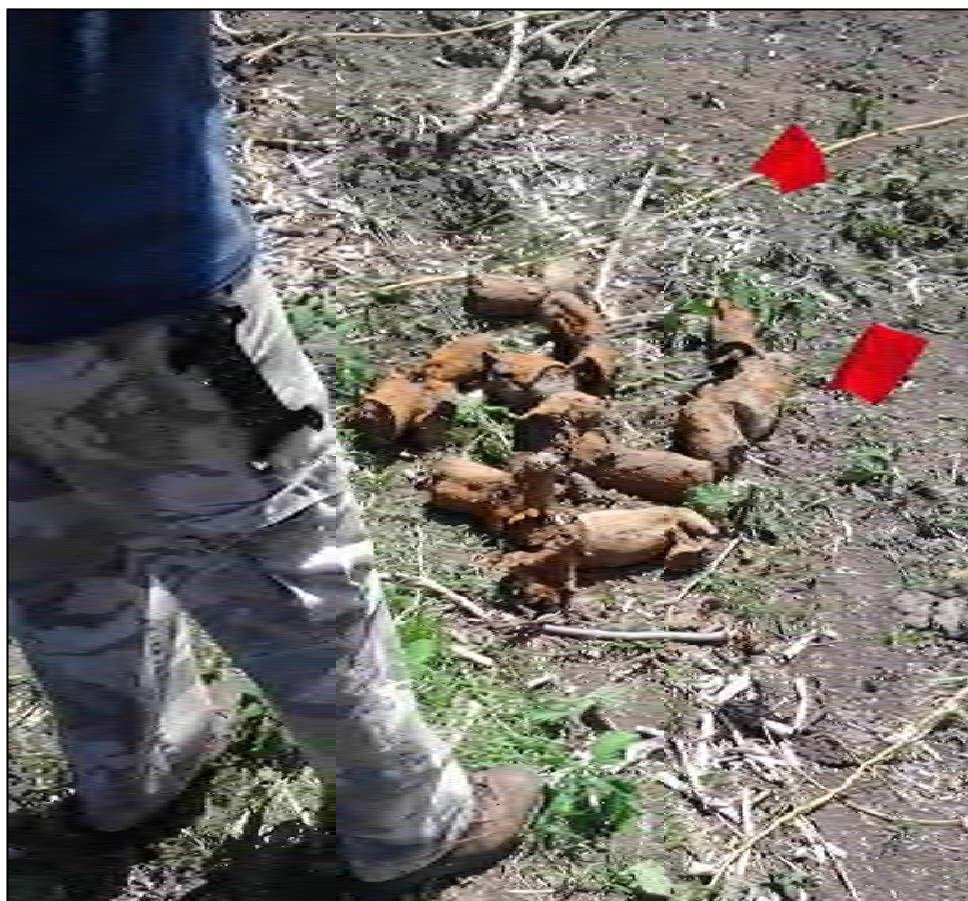
Photo 19 – MEC components (fuzes) recovered at the western planned parking area

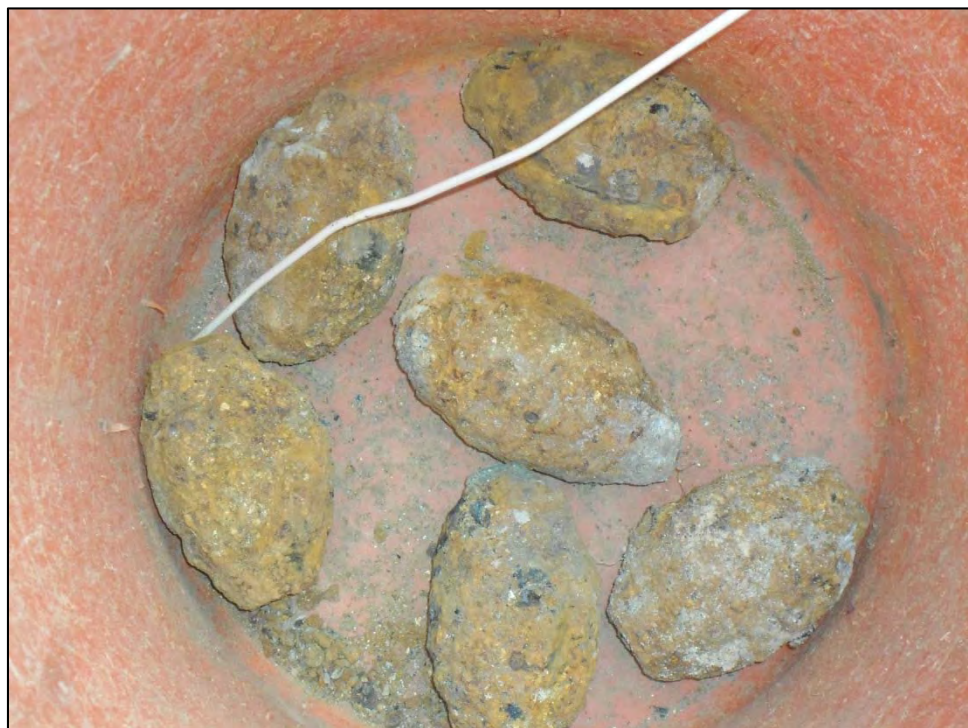
Photo 20 – Deteriorated grenades identified at SWMU 4

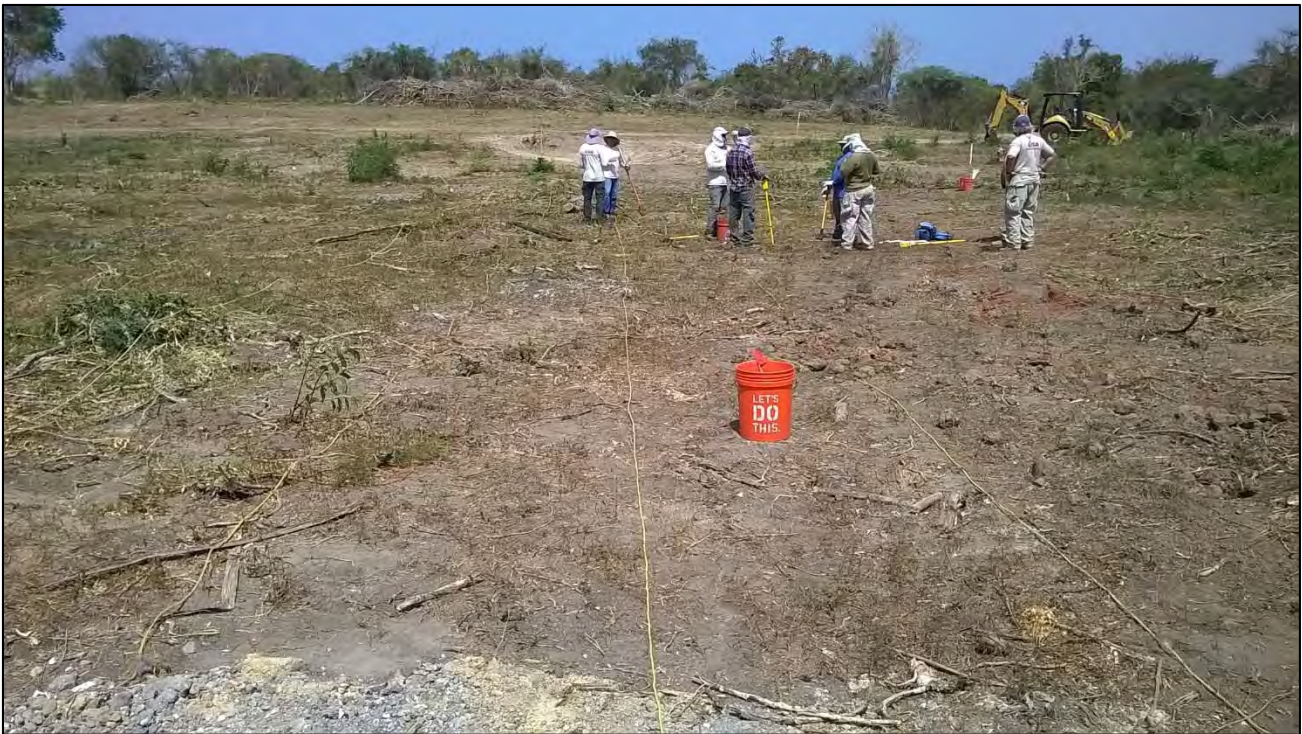
Photo 21 – Mag-and-dig at SWMU 4

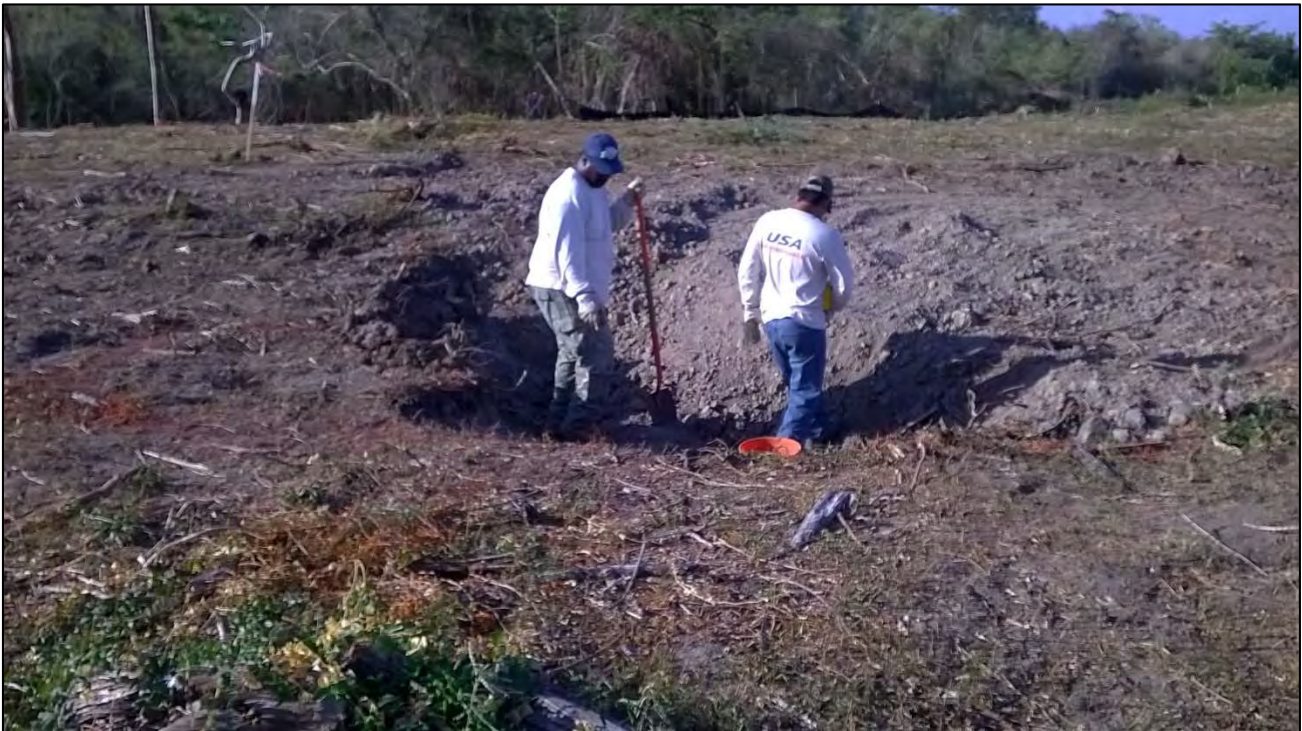
Photo 22 – Anomaly reduction in a demo pit near the planned western parking area at SWMU 4

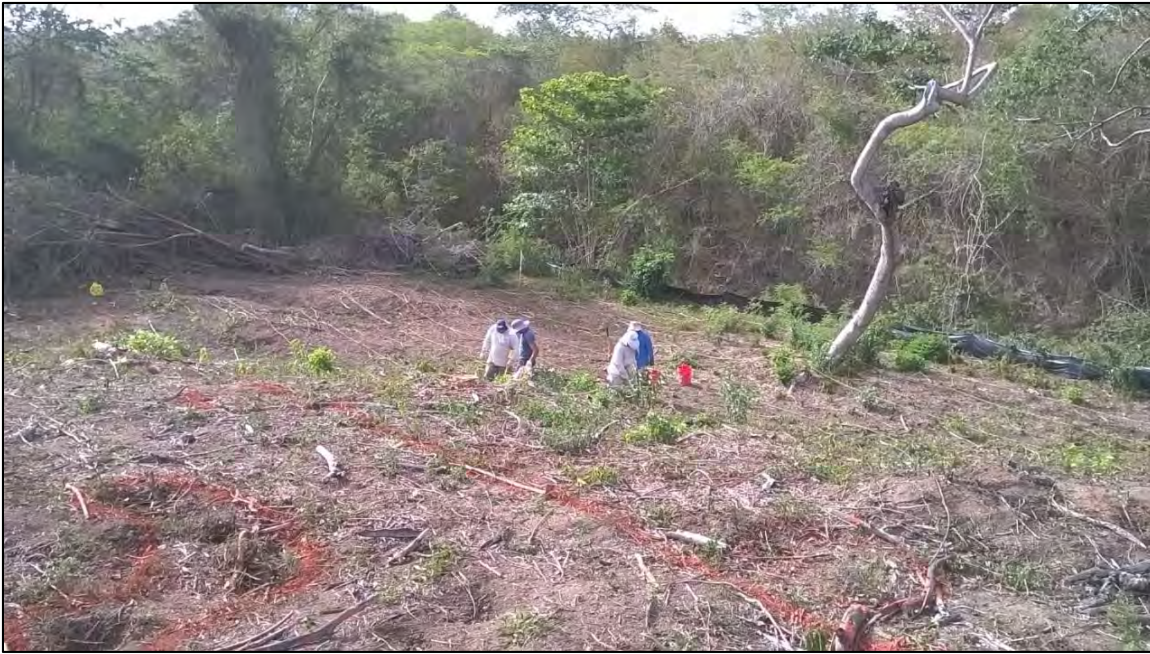
Photo 23 – Mag-and-dig at SWMU 4

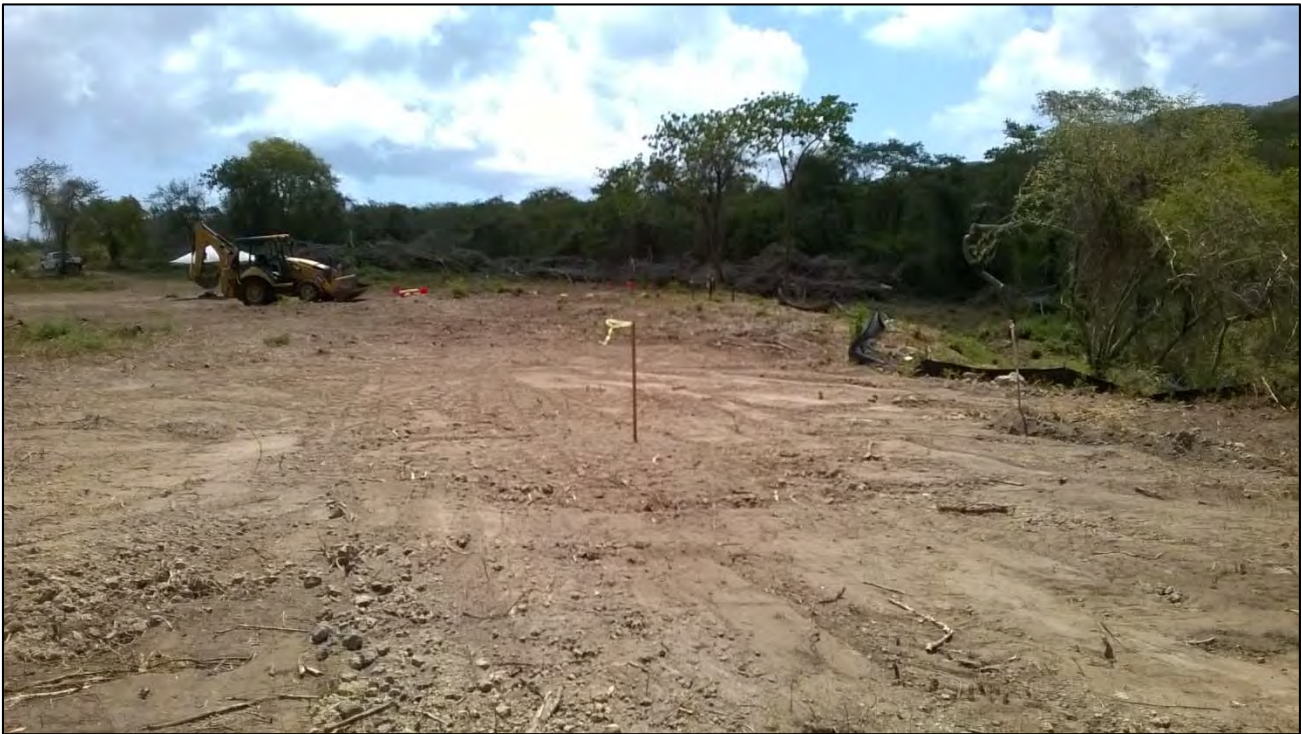
Photo 24 – An OB/OD location at SWMU 4 where mag-and-dig has been completed (stake marks center of OB/OD location)

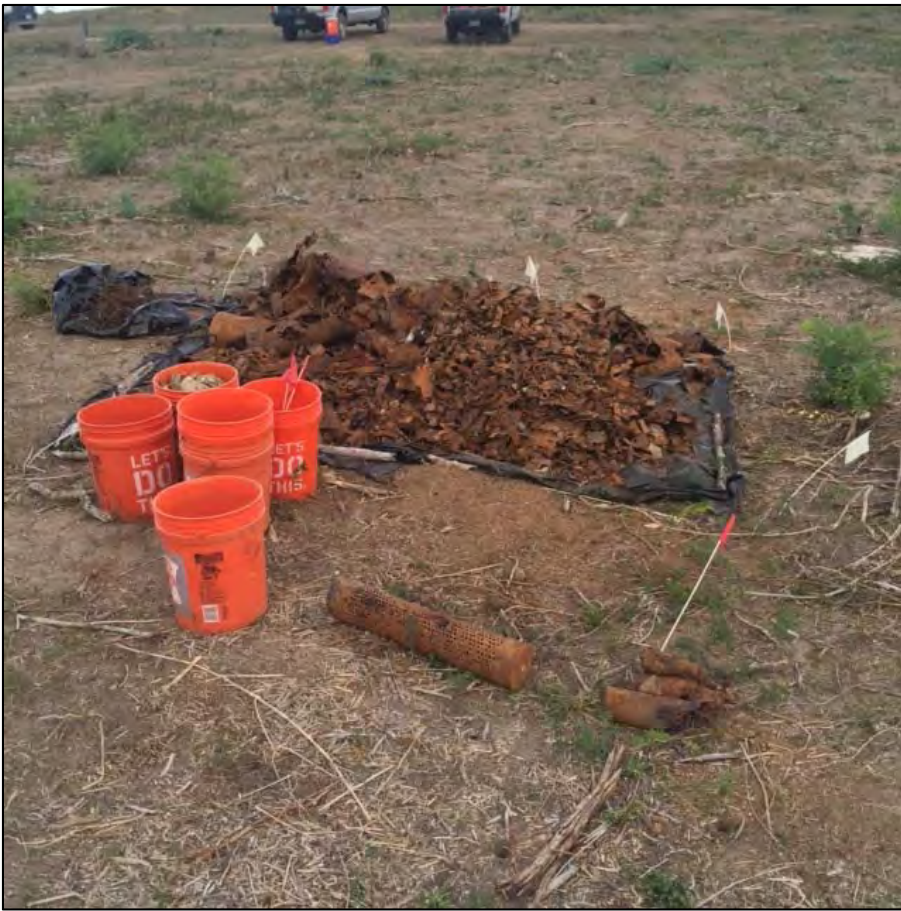
Photo 25 – Material removed from OB/OD area at SWMU 4

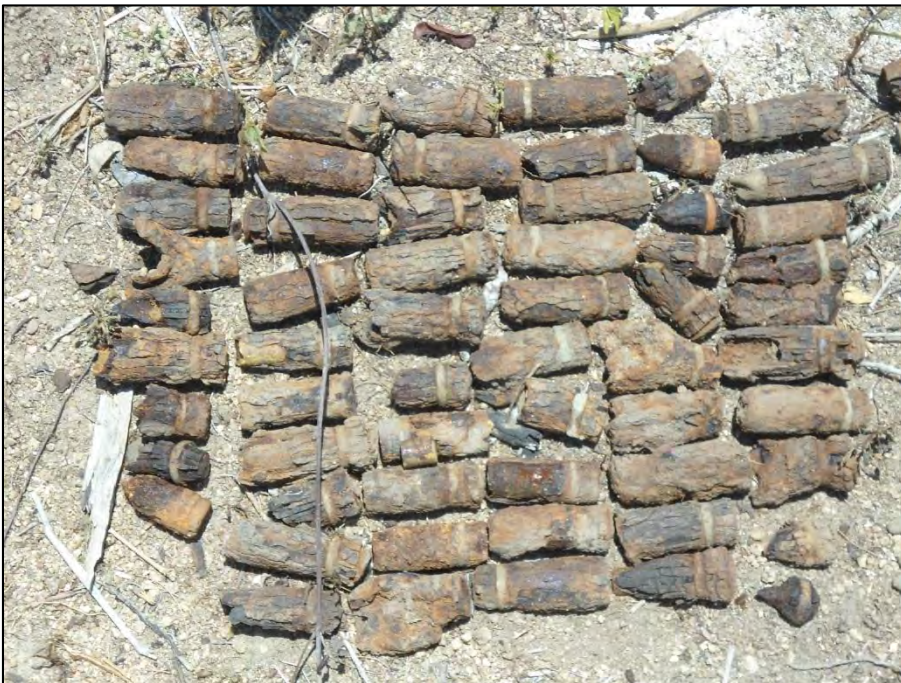
Photo 26 – 20-mm projectiles recovered at SWMU 4

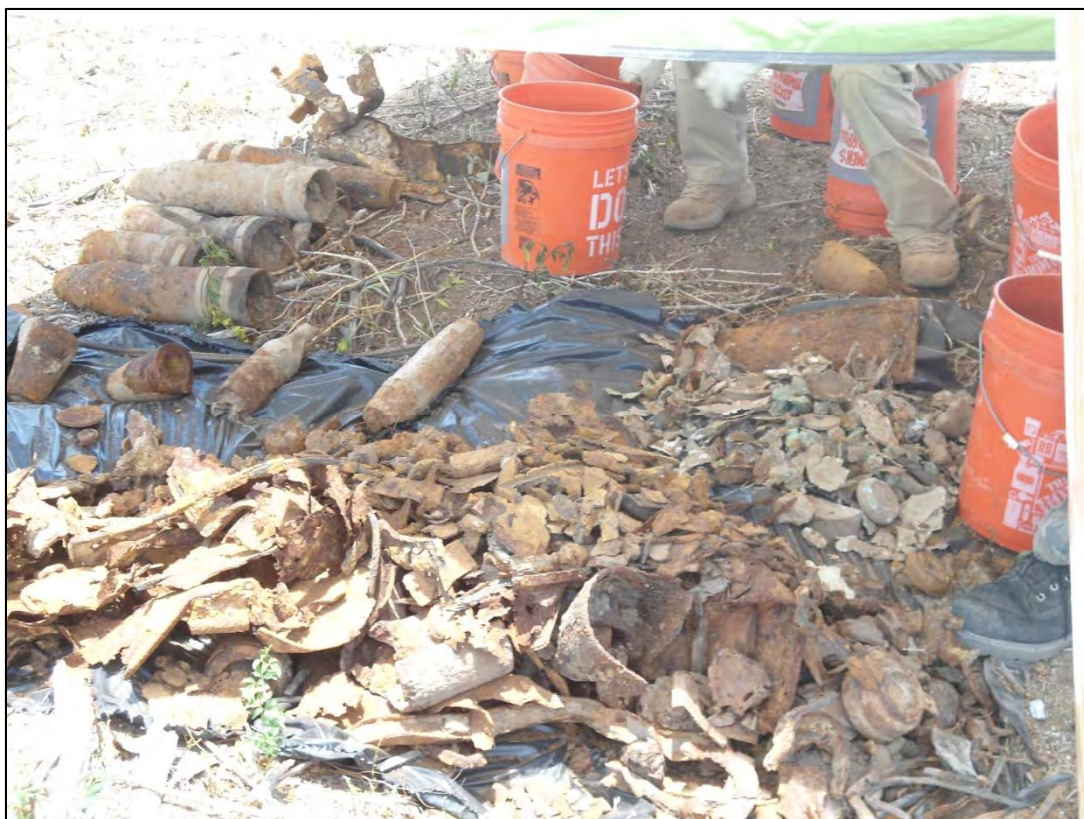
Photo 27 – MDAS, MD, and/or RRD recovered at SWMU 4 during the mag-and-dig and DGM anomaly removal activities

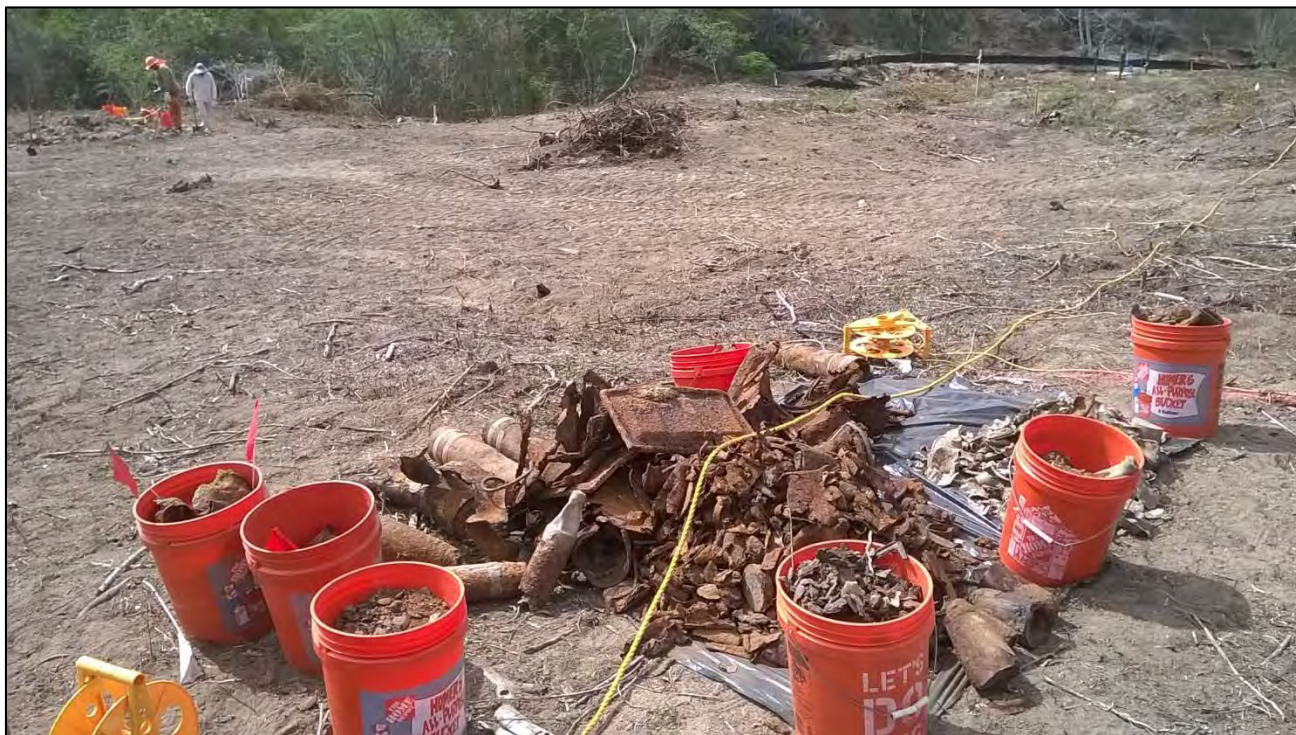
Photo 28 – MDAS, MD, and/or RRD recovered at SWMU 4
